TECHNICAL REPORT NO. 7878

300 FOOT RADIO TELESCOPE -
FRACTURED MAIN BOX GIRDER PLATE

Report No. ME-1115

Subject: 300 FOOT RADIO TELESCOPE -
FRACTURED MAIN BOX GIRDER PLATE

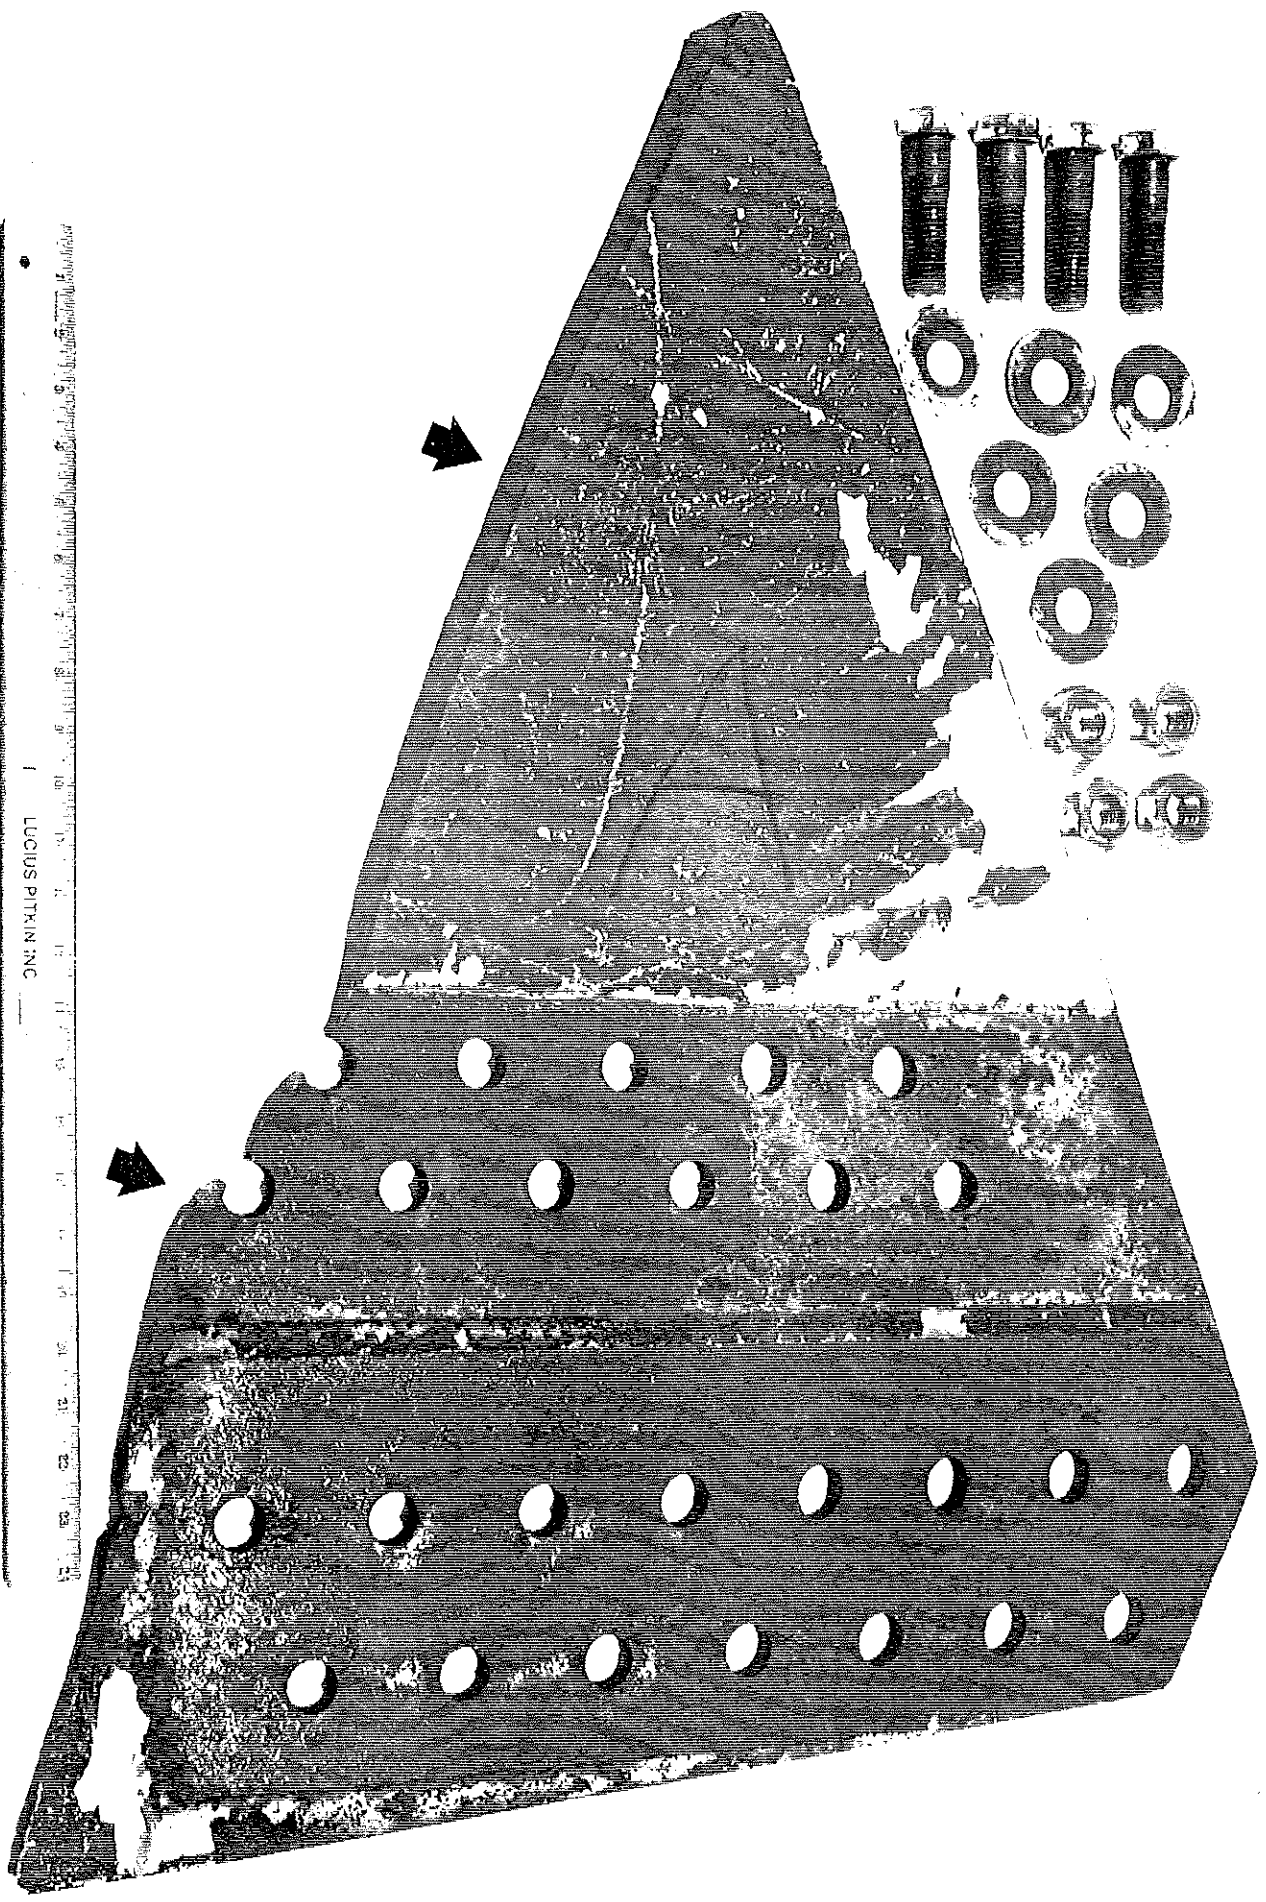
Fig. 1

The submitted section of 1/2-in. thick fractured main box girder plate is shown in the as-received condition in Fig. 1. Examination of the subject plate revealed the fracture to be

approximately 37 inches long and passed through two bolt holes apparently used to fasten an adjacent gusset plate.

FAILED MAIN BOX GIRDER PLATE,
AS-RECEIVED

Photograph showing the submitted 1/2-in. thick main box girder plate from the 300 ft. radio telescope at Greenbank, West Virginia, in the as-received condition. The plate fracture was approximately 37 in. long (arrows) and intersected two bolt holes.

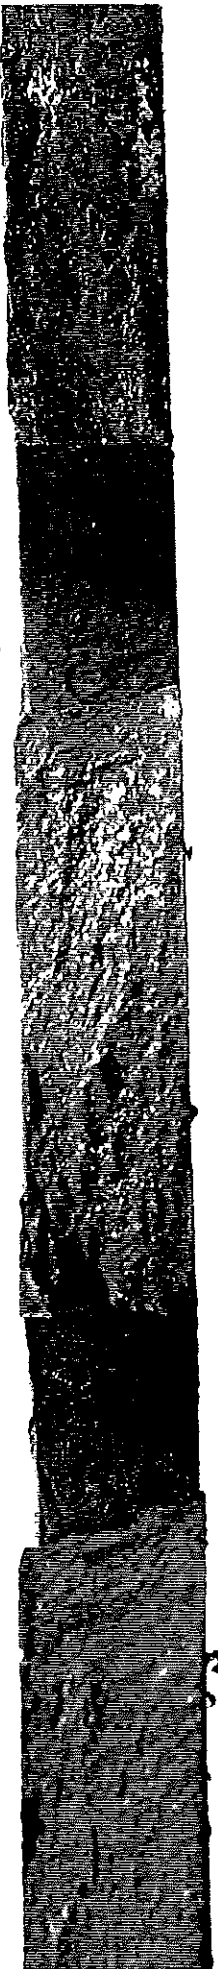
Visual examination revealed the majority of the fracture to be slanted and lightly oxidized (rusted), as is characteristic of a recent fast ductile fracture. Closer examination of the slanted fracture surfaces revealed faint chevron-like markings, the convergence of which indicated the bolt holes to be the fracture origins. The fracture surfaces adjacent to the bolt holes were relatively flat in appearance, exhibiting little or no plastic deformation, and were covered with a heavy black oxide. These heavily oxidized regions extended approximately 1-in. to 2-in. to each side of the bolt holes. The relatively flat and heavily oxidized appearance of the fracture surface adjacent to the bolt holes is characteristic of progressive long-term cracking in the nature of fatigue. Fig. 2 is a photograph showing the appearance of the plate fracture surfaces in the vicinity of the bolt holes.

PLATE FRACTURE SURFACE

Photograph showing the flat and heavily oxidized appearance of the plate fracture surfaces adjacent to the bolt holes. This flat and heavily oxidized fracture appearance is characteristic of long-term progressive or fatigue cracking. The convergence of chevron-like marks indicates the bolt holes to be the fracture origins.

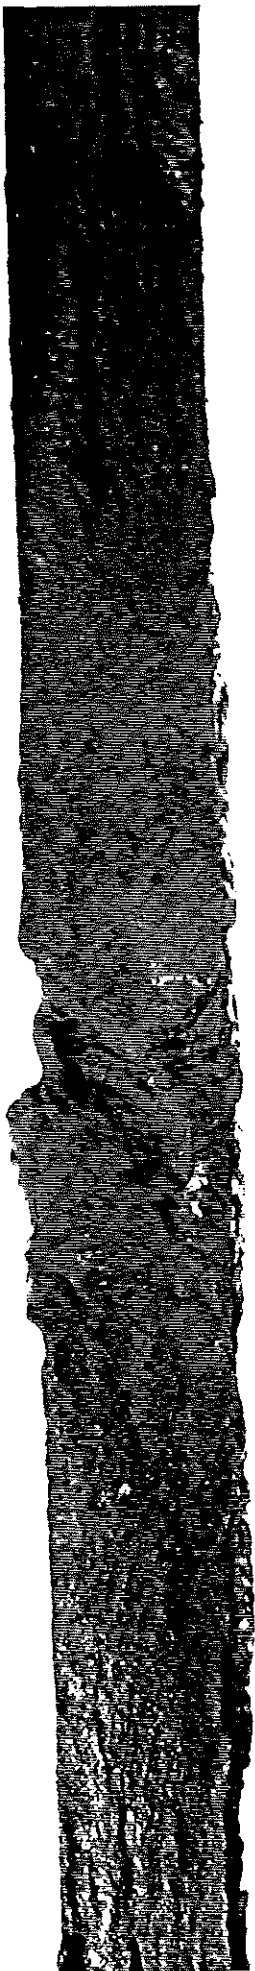
Fig. 3

In addition, approximately midway between the failed bolt holes and short edge of the plate, a 1/2-in. wide discontinuity intersected the fracture plane, as shown in Fig. 3. The appearance of this plate discontinuity was characteristic of weld metal deposit/splatter or an arc gouge. The fracture surface adjacent to this region was relatively flat and heavily oxidized indicating this damage may have been present for some time. It should be noted, however, that the fracture surface chevron-like ridges (which generally converge toward fracture origins) did not converge in the vicinity of the weld deposit/splatter and, as such, this discontinuity was not considered to be the primary fracture origin.

PLATE FRACTURE SURFACE DISCONTINUITY

Photograph showing a weld deposit/splatter or arc gouge discontinuity in the fracture plane approximately midway between the bolt holes and the short edge of the plate. The lack of converging chevron-like marks near this discontinuity indicated it was not a primary fracture origin.

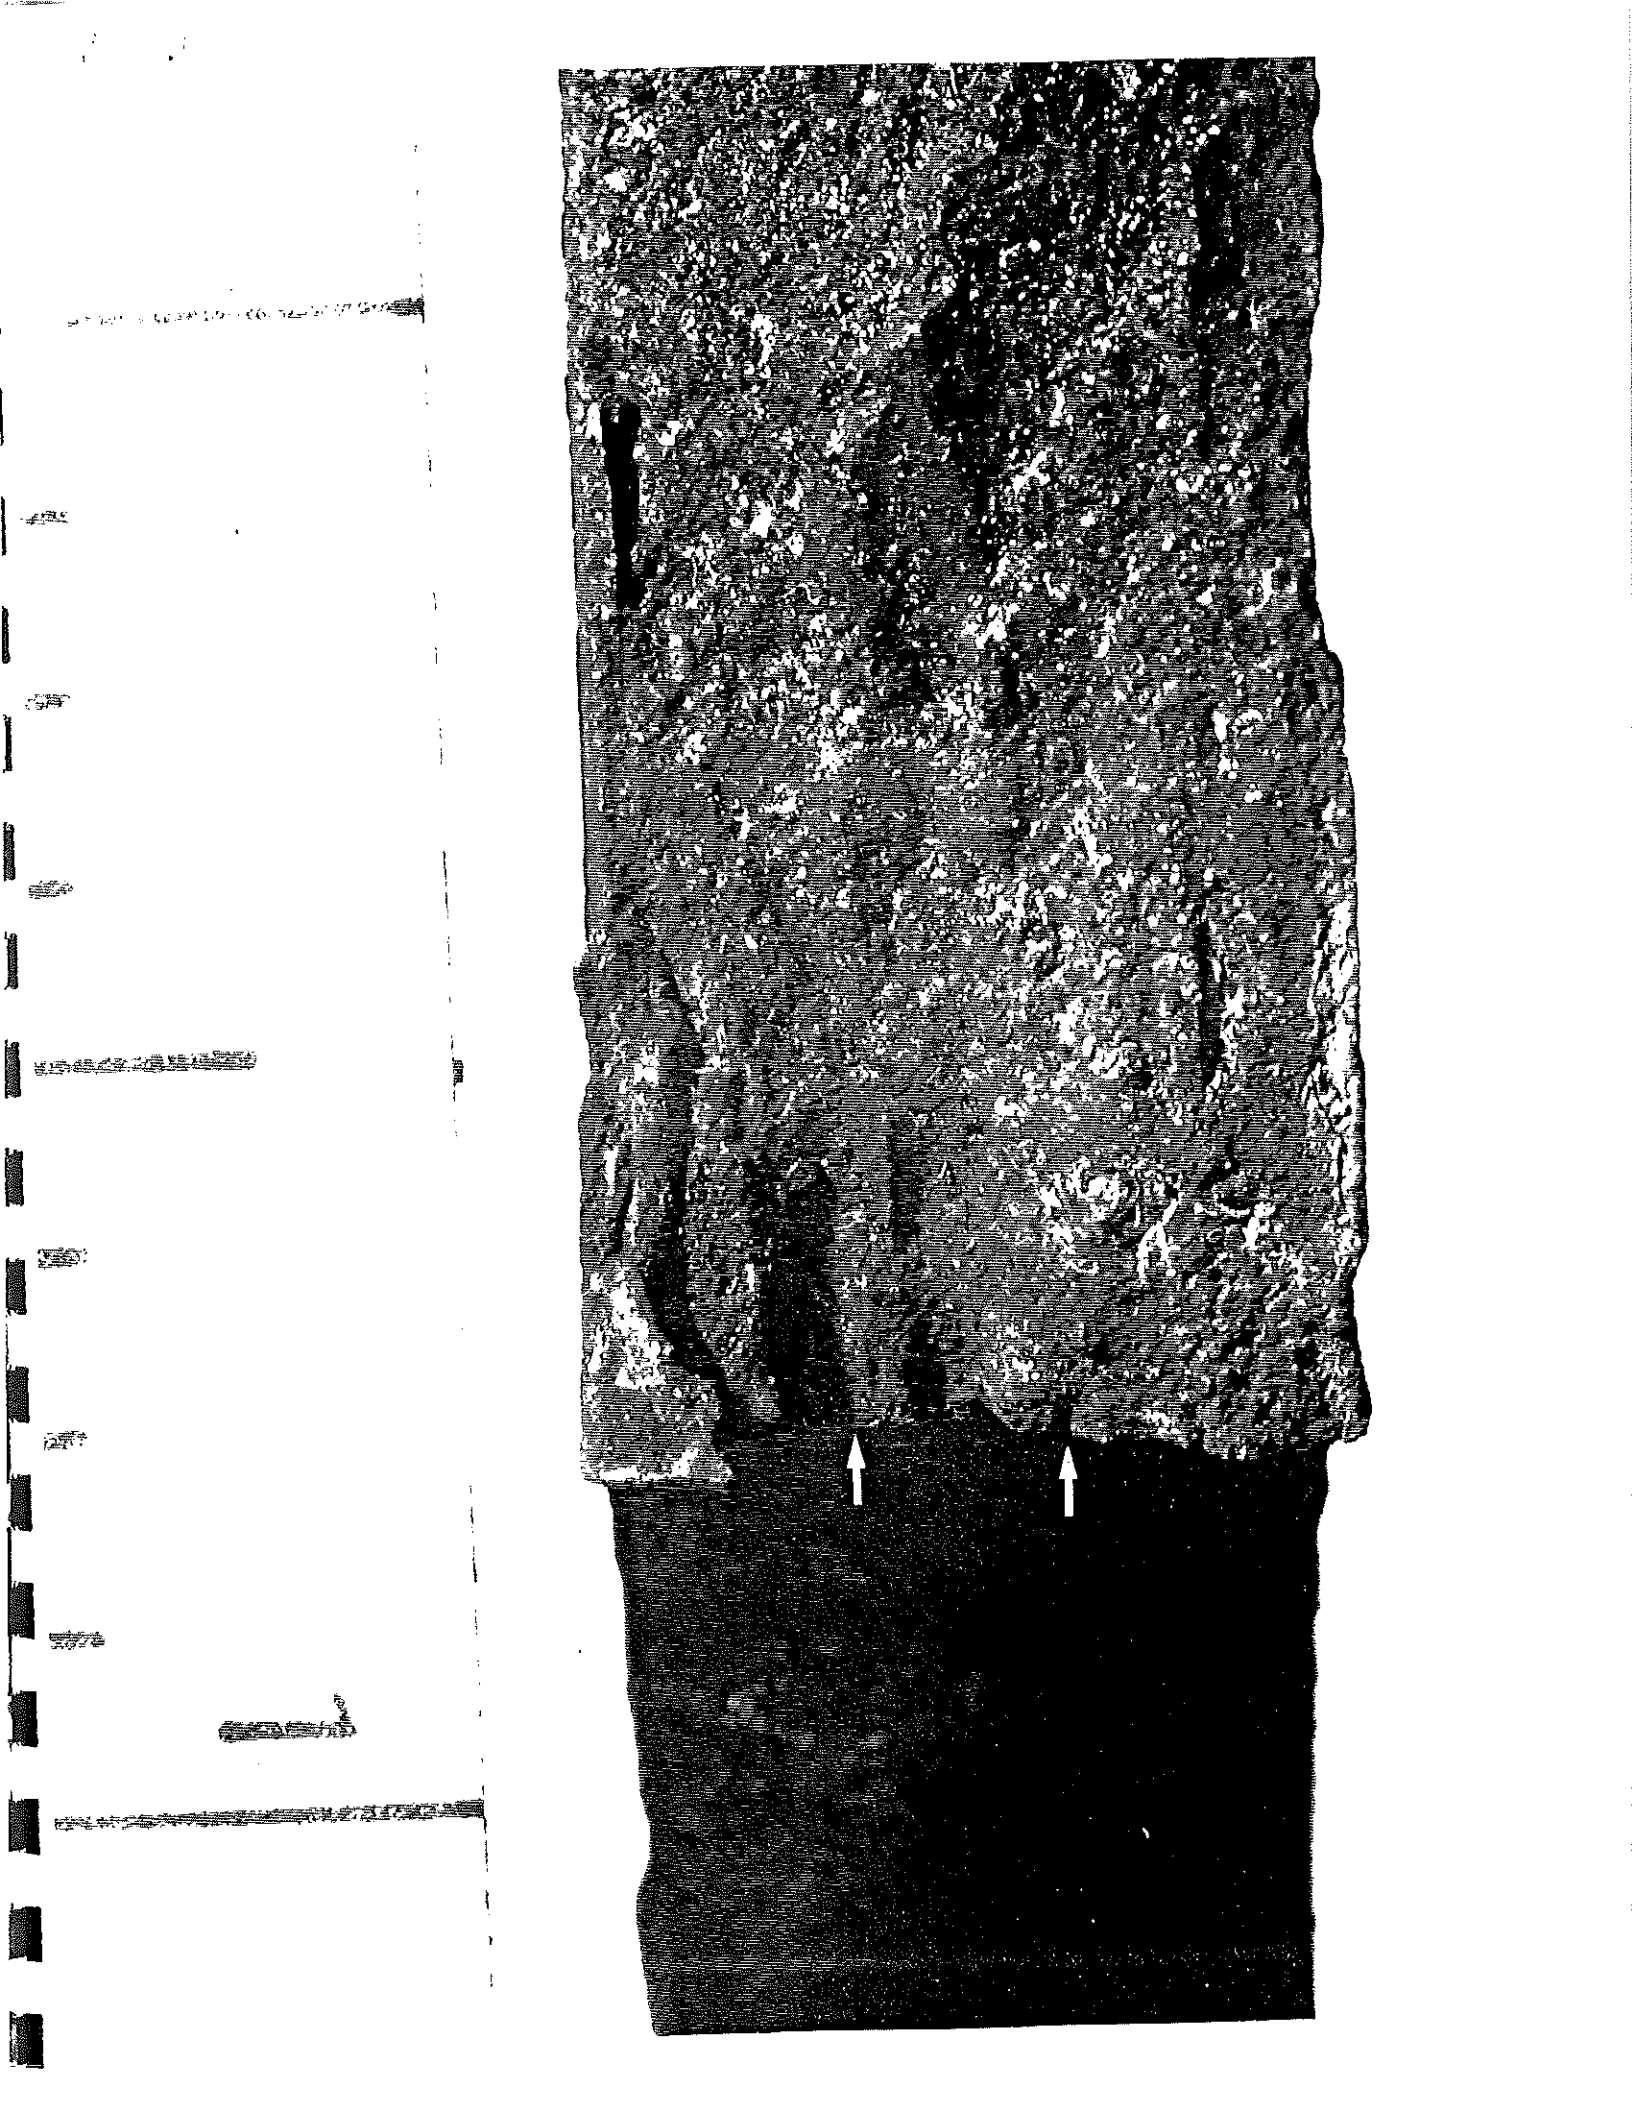
Fig. 4

Close examination of the fracture surface adjacent to the bolt holes revealed the presence of ratchet marks at the bolt hole surfaces, as shown in Figs. 4 and 5, as is characteristic of fatigue crack initiation. In addition, as shown in Figs. 6 and 7, secondary cracks parallel to and below the primary fracture were also observed at the bolt holes. The presence of secondary cracks is also characteristic of fatigue crack growth and these cracks generally occur under moderate to high cyclic stresses.

FRACTURE ORIGIN

Close-up photograph showing the presence of fracture surface ratchet marks (arrows) at the bolt hole surfaces, as is characteristic of progressive crack initiation in the nature of fatigue.

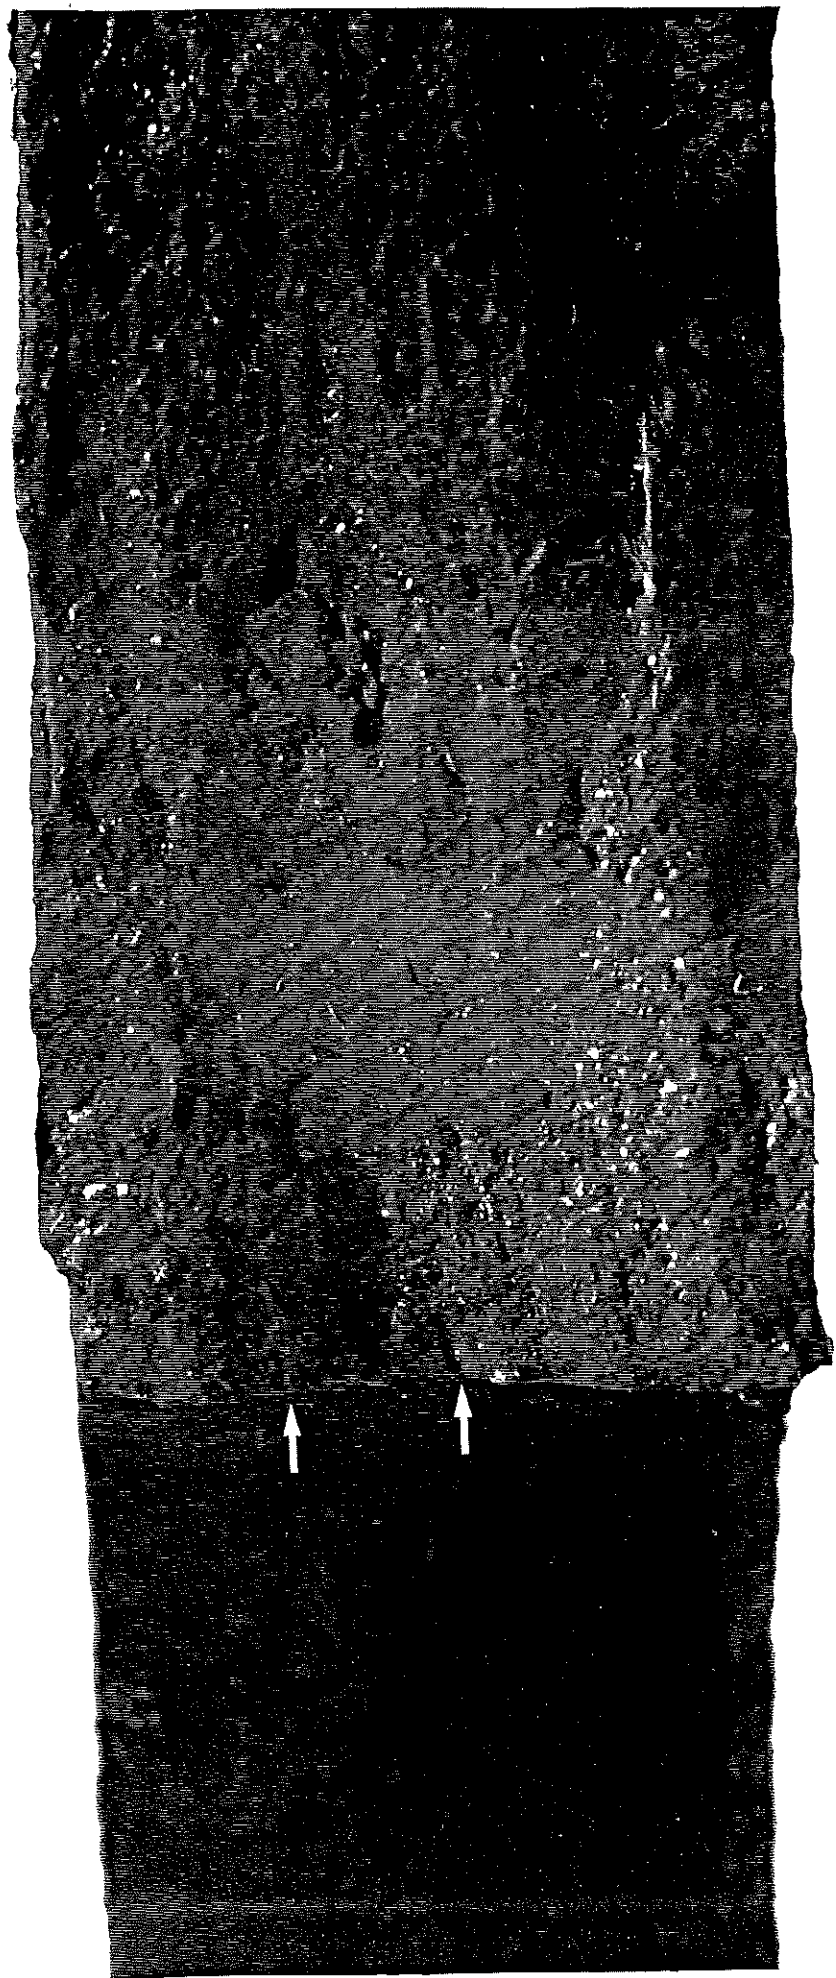
Fig. 5

FRACTURE ORIGIN

Close-up photograph showing the presence of fracture surface ratchet marks (arrows) at the bolt hole surfaces, as is characteristic of progressive crack initiation in the nature of fatigue.

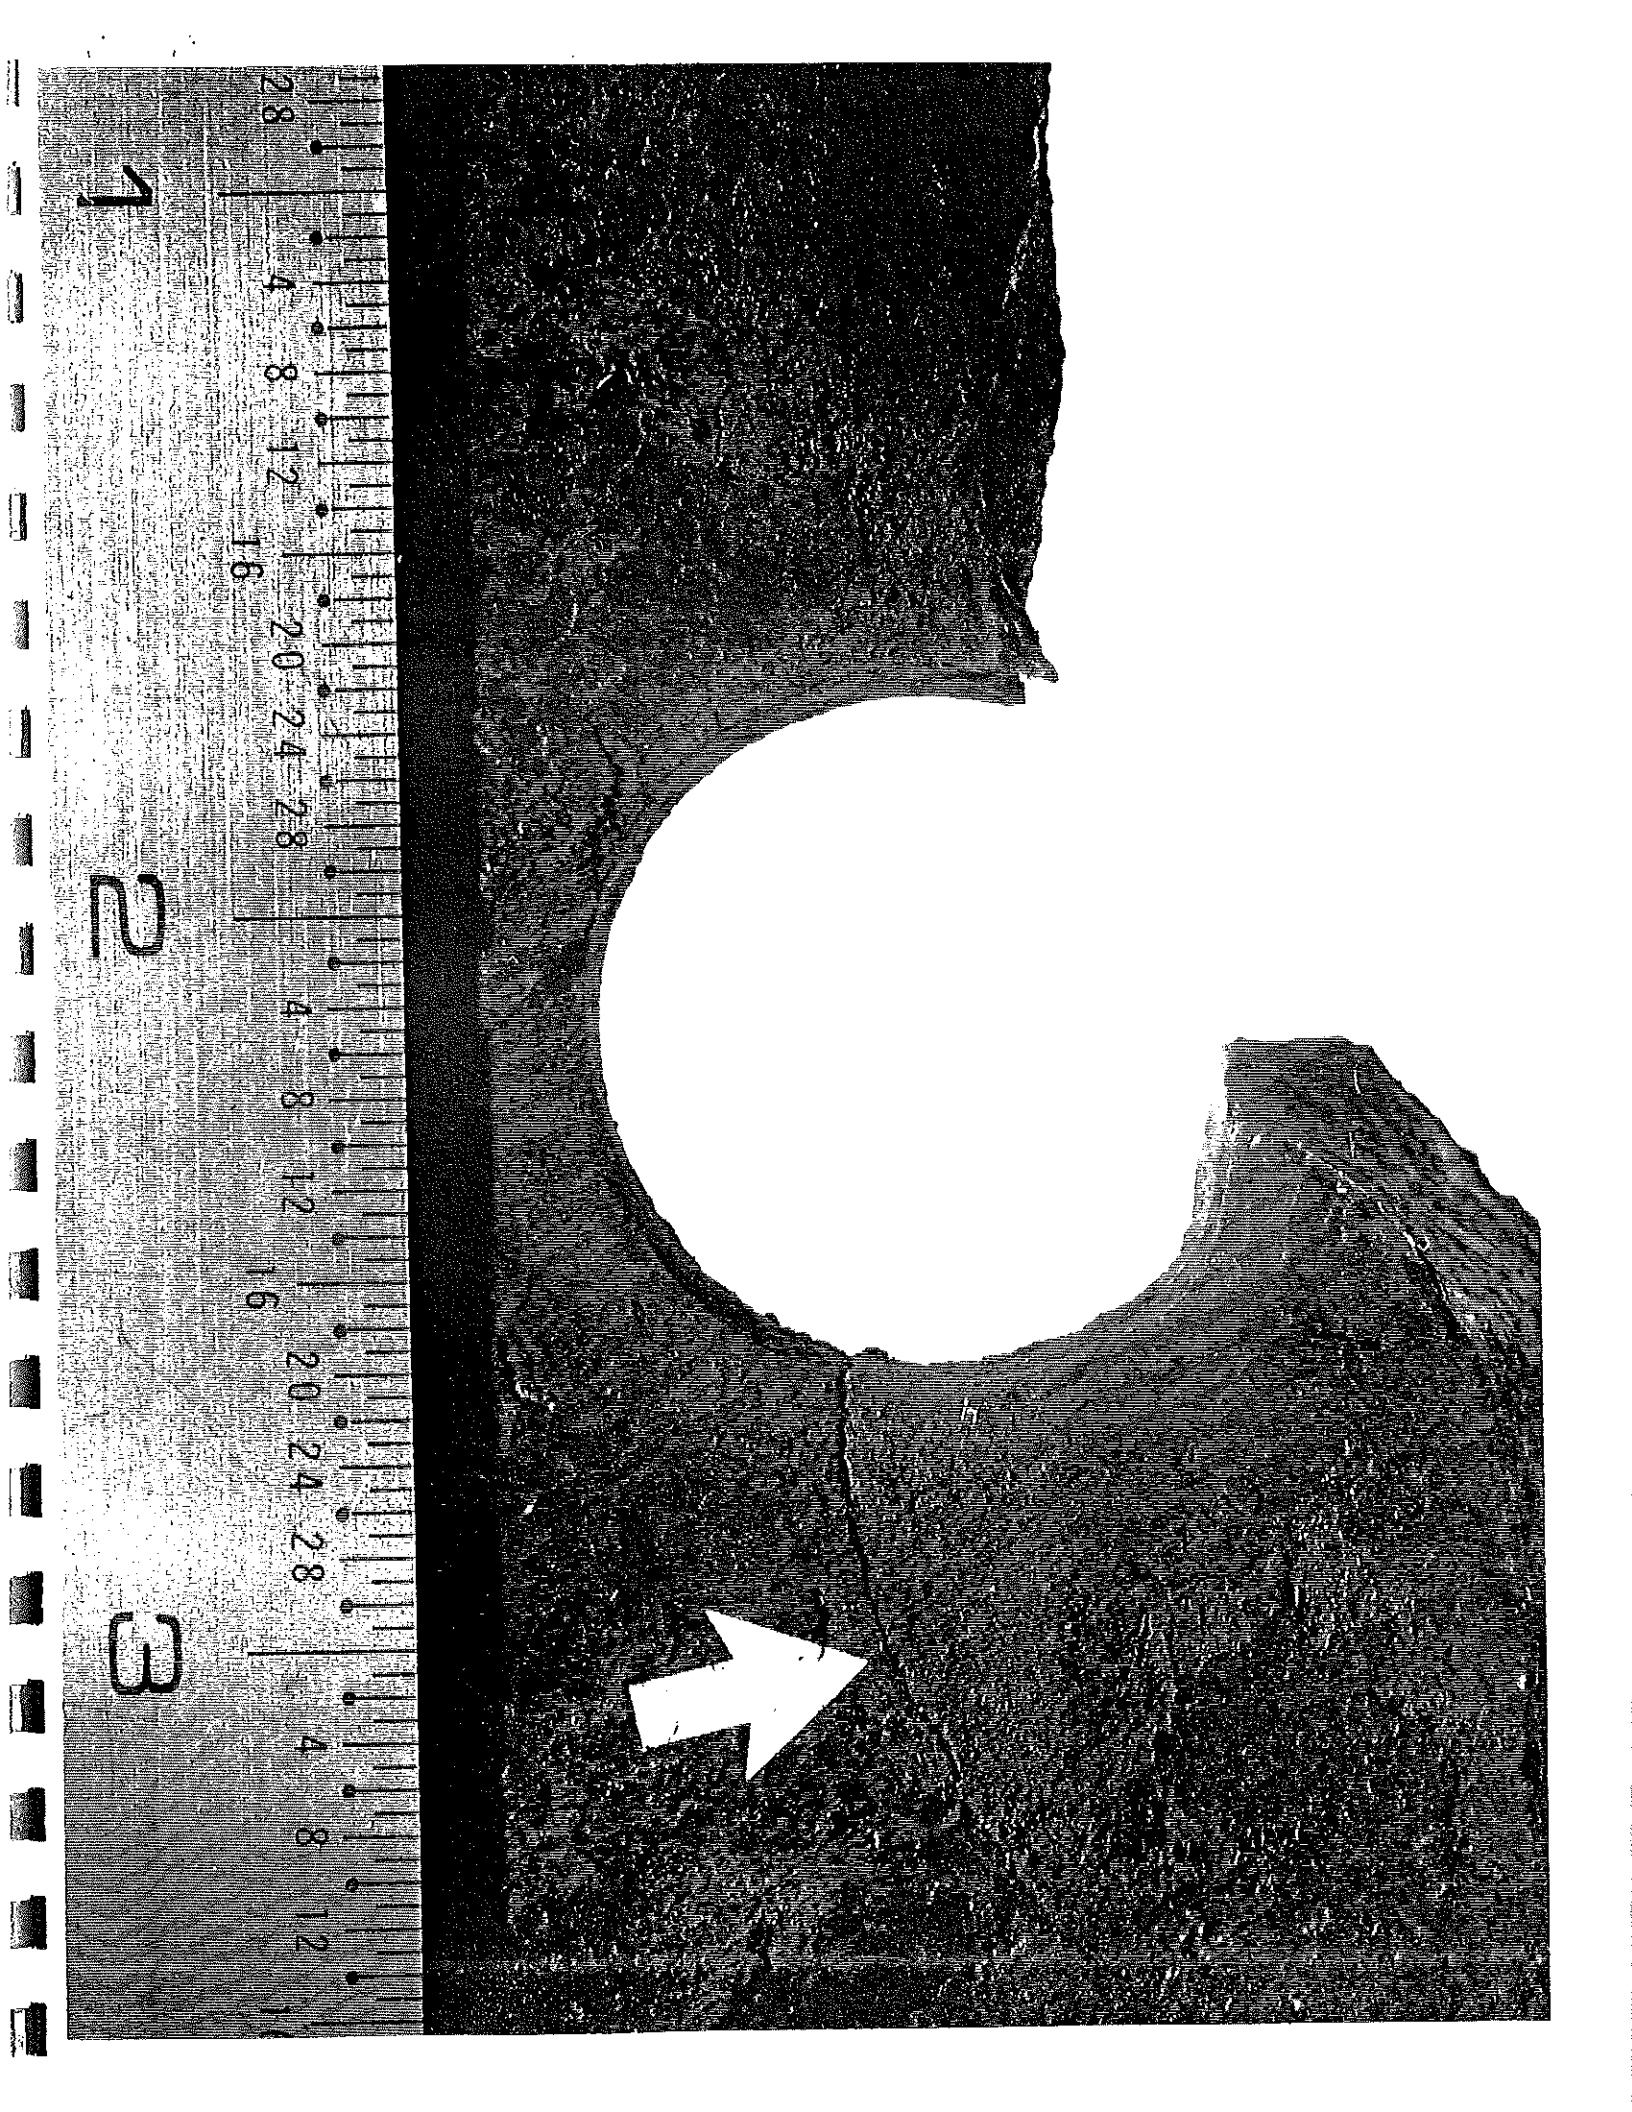
Fig. 6

SECONDARY FATIGUE CRACK

Close-up photograph showing a secondary fatigue crack (arrow) parallel and adjacent to the primary fracture, as is characteristic of fatigue cracking under intermediate to high cyclic stresses.

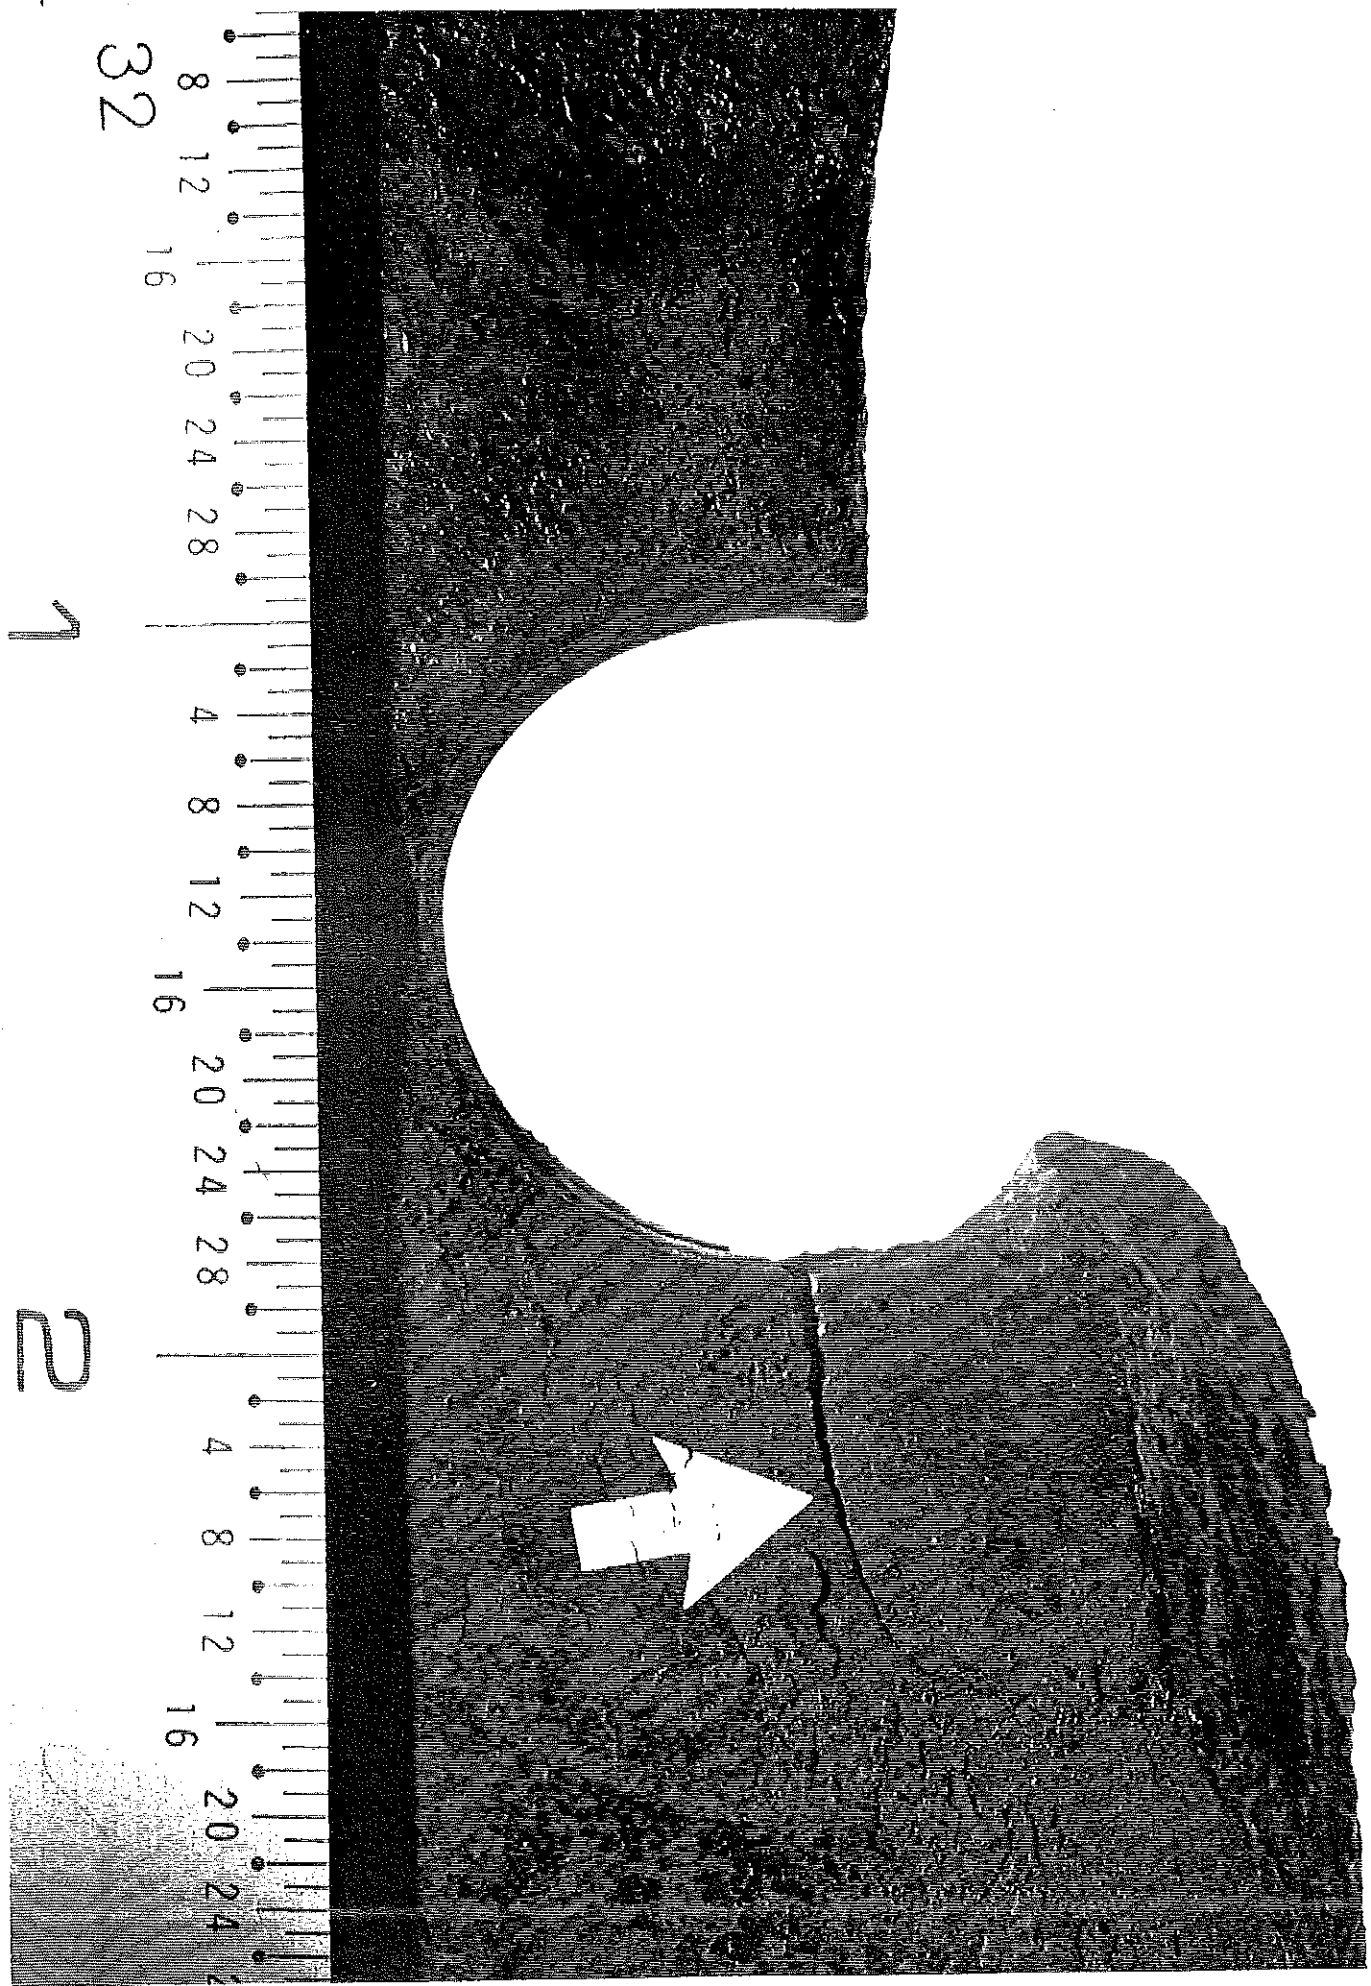
Fig. 7

SECONDARY FATIGUE CRACK

Close-up photograph showing a secondary fatigue crack (arrow) parallel and adjacent to the primary fracture, as is characteristic of fatigue cracking under intermediate to high cyclic stresses.

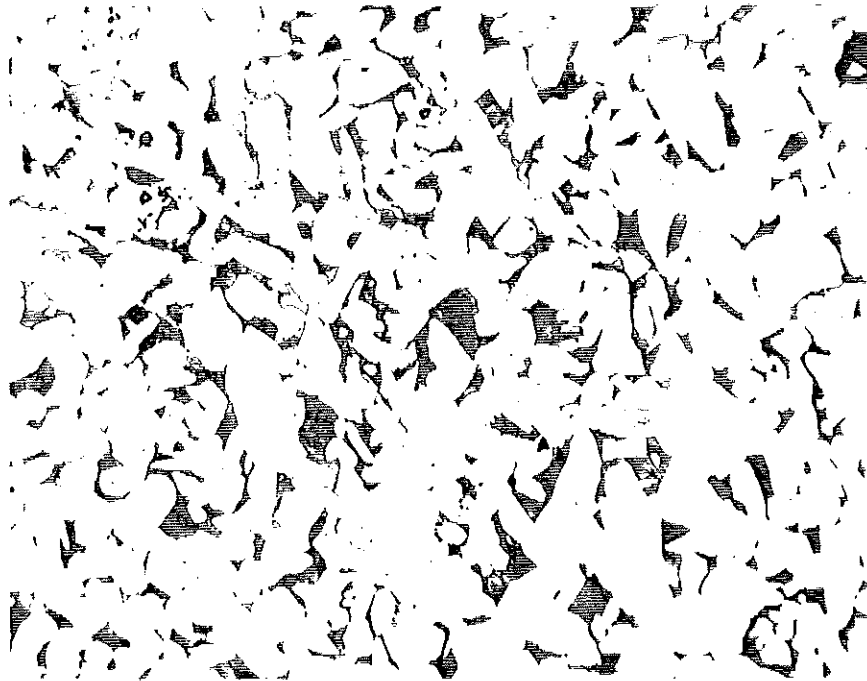
Etching the microspecimens revealed the general microstructure of the plate material to be comprised of fine grained ferrite (iron phase) and pearlite (iron iron-carbide phase), as is characteristic of a plain carbon structural steel. Fig. 8 is a photomicrograph showing the general microstructure of the plate material.

GENERAL MICROSTRUCTURE

Photomicrograph showing the general microstructure of the main box girder plate material to be comprised of fine grained ferrite (iron phase) and pearlite (iron iron-carbide phase), as is typical of a plain carbon steel.

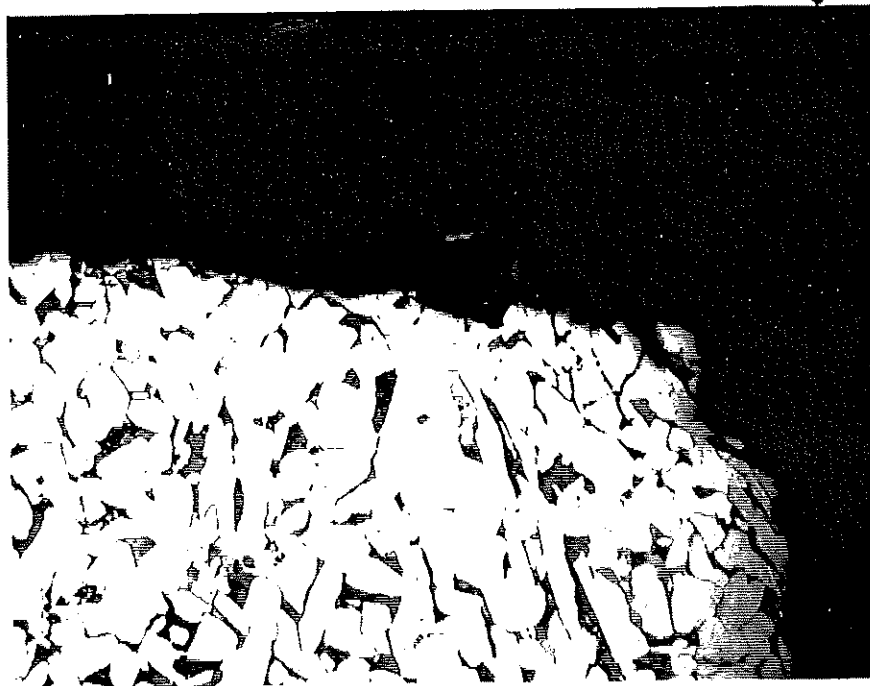
Examination of the fracture regions adjacent to the bolt holes revealed fracture profiles which were relatively flat and transgranular (propagating through the grains rather than along grain boundaries), as is typical of progressive or fatigue failure under cyclic loading. Fig. 9 is a photomicrograph showing the transgranular fracture profile adjacent to a bolt hole. Further, as shown in Fig. 10, small secondary transgranular cracks parallel to the primary fracture were also observed at the bolt hole surfaces. The presence of secondary cracks are characteristics of fatigue fracture at moderate to high cyclic stresses.

FRACTURE PROFILE AT ORIGIN

Photomicrograph showing the box girder plate fracture profile (top) at the fracture origin (bolt hole surface - right side) to be relatively flat and transgranular, as is characteristic of progressive cracking in the nature of fatigue.

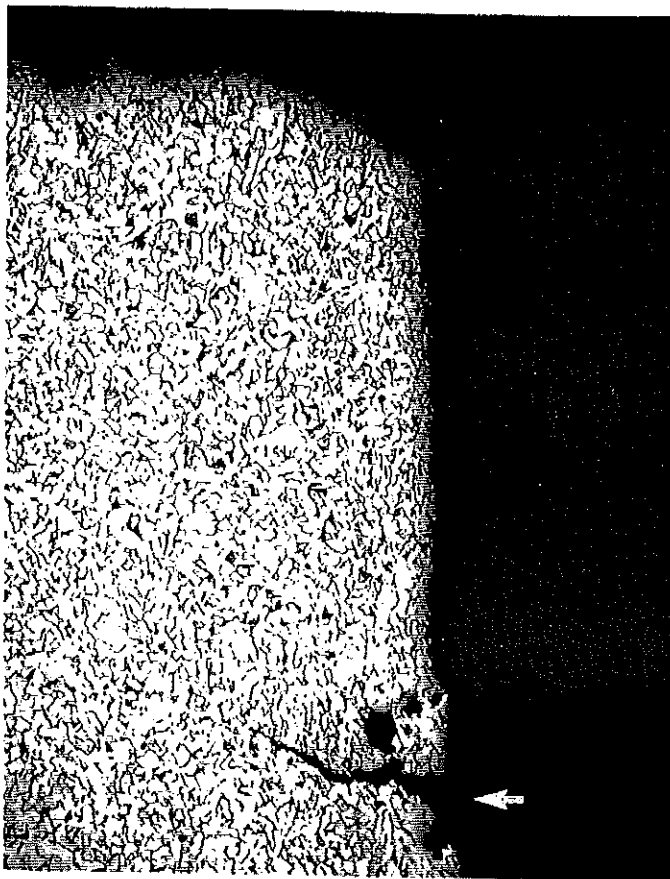
Fig. 10

SECONDARY FATIGUE CRACK

Photomicrograph showing a secondary fatigue crack (arrow) parallel to and just below the primary fracture (top) at the bolt hole surface (right side). The presence of secondary cracks is characteristic of fatigue fracture at moderate to high cyclic stresses.

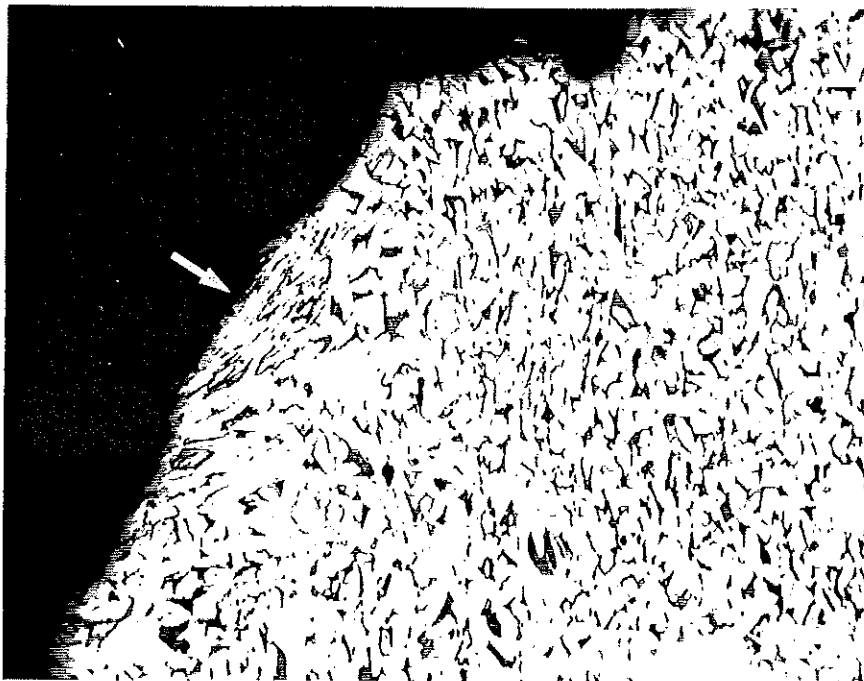
Remote from the fracture origin, the final fracture profile was slanted, transgranular and the grains adjacent to the surface were plastically deformed, as is characteristic of fast ductile fracture. Fig. 11 is a photomicrograph showing fracture profile through the final fracture region.

FRACTURE PROFILE REMOTE
FROM BOLT HOLE ORIGIN

Photomicrograph showing the slanted and transgranular fracture profile of the plate fracture remote from the bolt hole origin. In addition, the grains adjacent to the fracture surface (arrow) are plastically deformed, as is characteristic of fast ductile fracture.

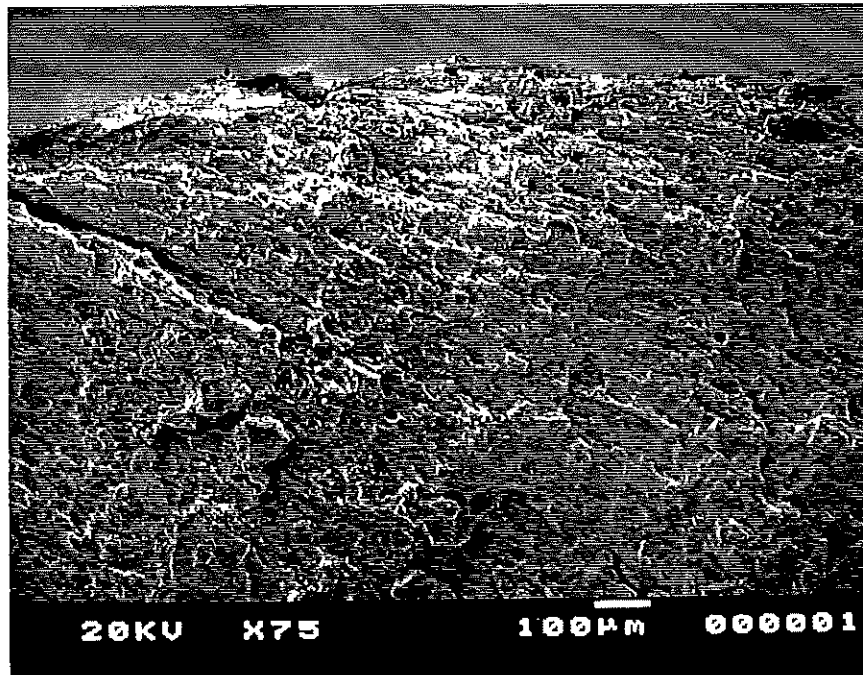
Fig. 12

As shown in Fig. 12, the fracture surface was covered with an oxide scale and no significant fractographic information was obtained.

FRACTURE ORIGIN AT ORIGIN

Scanning electron micrograph showing the box girder plate fracture surface at a bolt hole fracture origin. Even after extensive cleaning procedures the fracture surface exhibited a tenacious oxide, thus, no significant fractographic information was obtained.
